GEOTECHNICAL ENGINEERING INVESTIGATION REPORT

PYRITE REMEDIATION for COURTHOUSE PARKING GARAGE WASHINGTON, PENNSYLVANIA

GMI PROJECT NO. 16051

Re: Ground Floor Heaving
Courthouse Parking Garage
Washington, PA

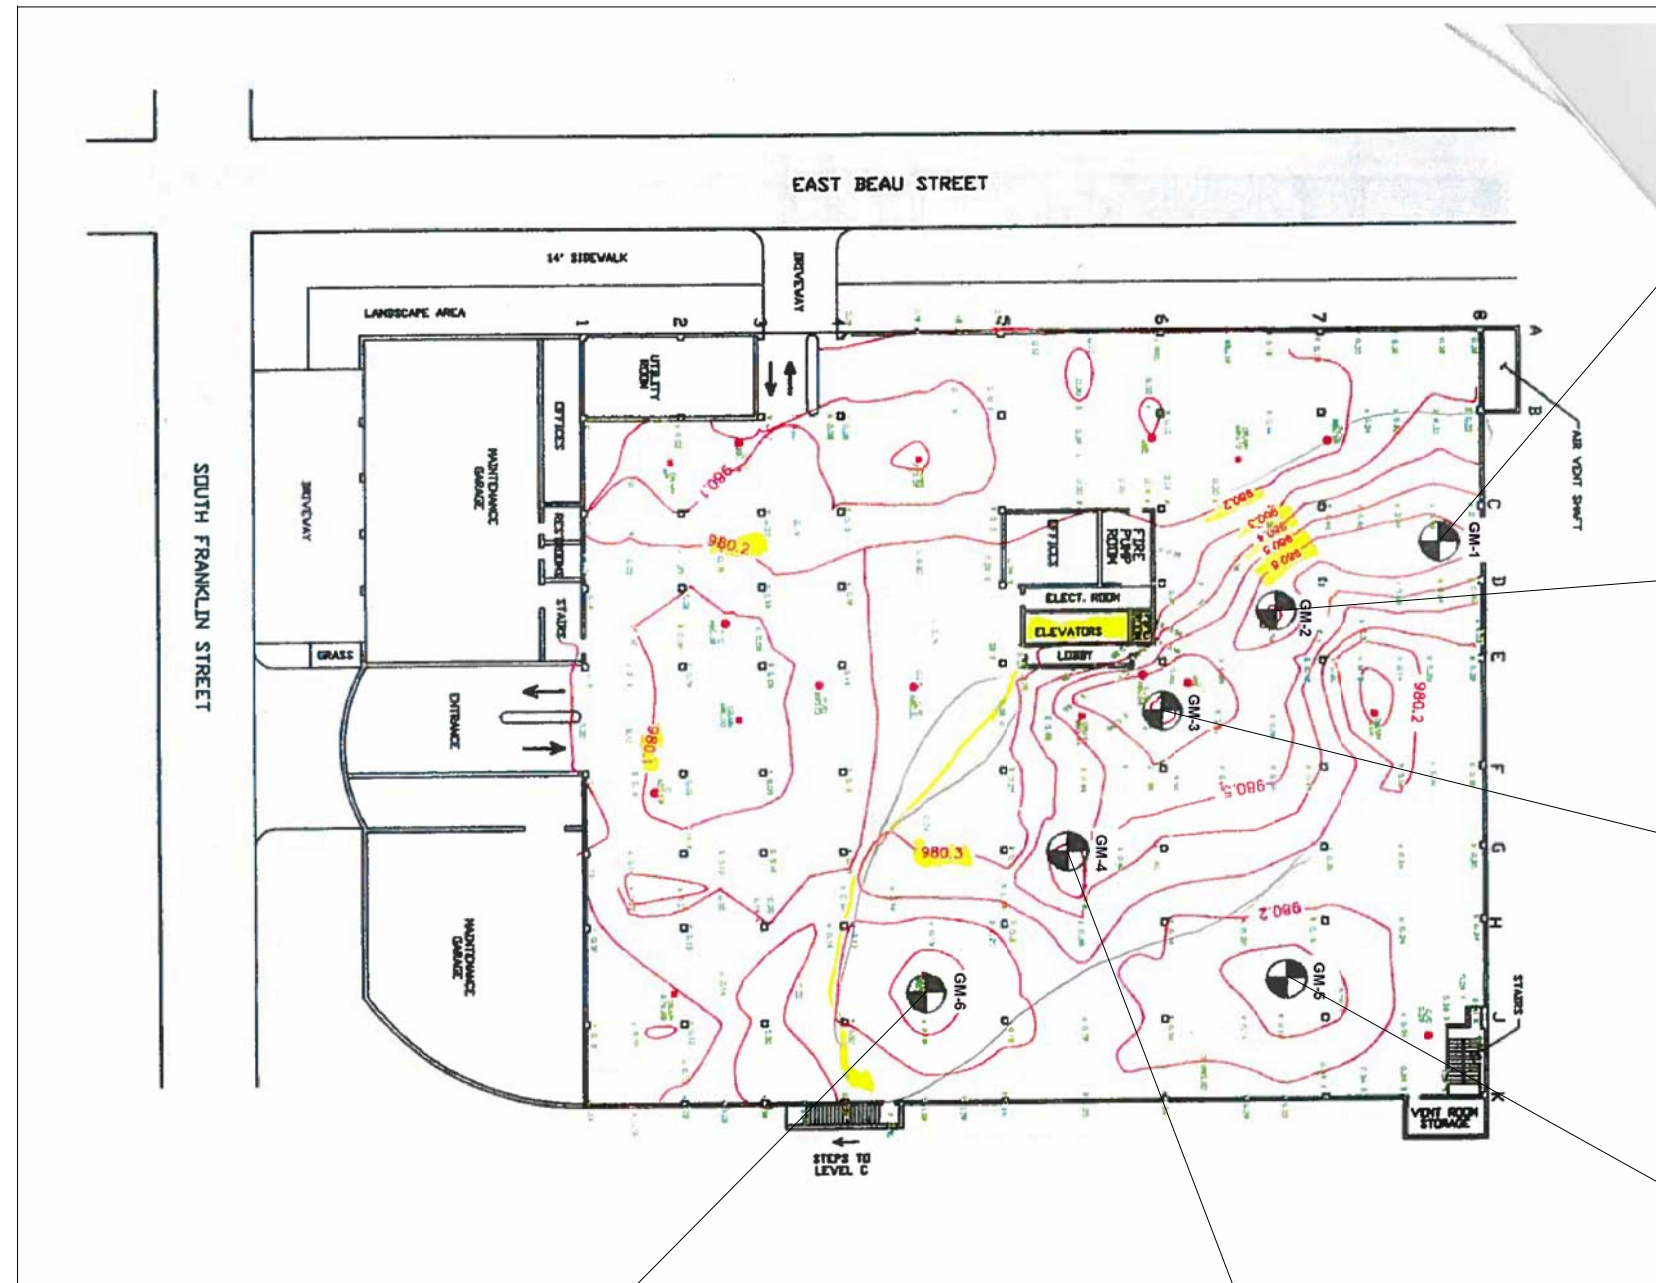
FIGURE:
8

GM-1
ELEV. 981±
CONCRETE
0.4'
Brown CLAYEY SAND
With Gravel
2.5' Gray Decomposed Carbonaceous SHALE
3.0' FRAGMENTS With Sand
END OF BORING
AT 3.0'
DRY HOLE, 0-HR.

GM-3
ELEV. 981±
CONCRETE
0.4'
Brown CLAYEY SAND
2.5' Gray CLAYEY GRAVEL With Sand
3.4' (DECOMPOSED CARBONACEOUS SHALE)
END OF BORING
AT 3.4'
DRY HOLE, 0-HR.

GM-5
ELEV. 980±
CONCRETE
0.5'
Gray SILTY CLAY With Sand
2.0'
Gray CLAYEY SAND With Gravel
(DECOMPOSED CARBONACEOUS SHALE)
5.0'
END OF BORING
AT 5.0'
DRY HOLE, 0-HR.

GM-6
ELEV. 981±
CONCRETE
0.4'
Gray-Brown CLAYEY
GRAVEL With Sand
3.5' Gray CLAYEY SAND With Sand
(DECOMPOSED CARBONACEOUS
5.5' SHALE)
END OF BORING
AT 5.5'
DRY HOLE, 0-HR.

GM-4
ELEV. 980±
CONCRETE
0.4'
Brown CLAYEY SAND With
Decomposed Carbonaceous
Shale Fragments
3.5'
END OF BORING
AT 3.5'
DRY HOLE, 0-HR.
